**FIVE-YEAR REVIEW REPORT FOR
KERR-MCGEE CHEMICAL CORPORATION SUPERFUND SITE
CARIBOU COUNTY, IDAHO**

Prepared by:
CH2MHILL.
Boise, Idaho

Prepared for:
U.S. Environmental Protection Agency
Region 10
Seattle, Washington

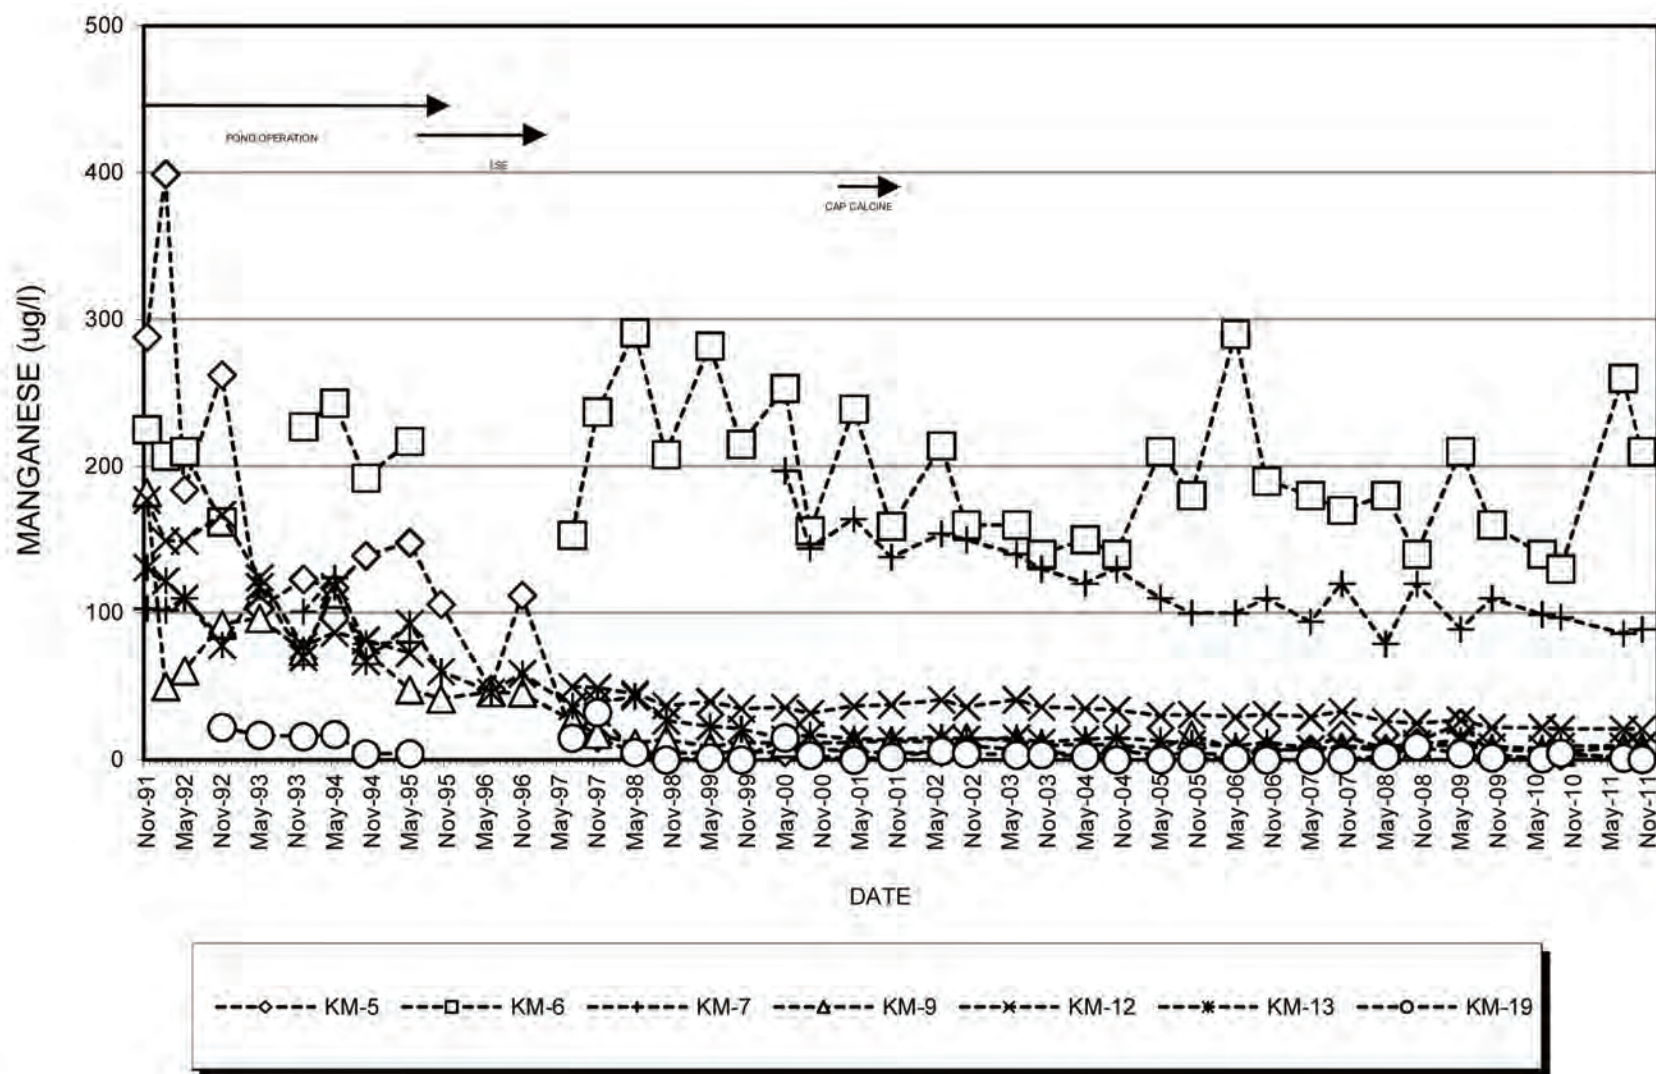
FIGURE 8
Manganese vs. Time
Wells Near West Side of Facility or
Near Former S-X Pond
Kerr-McGee 2012 Five Year Review

Figure 8 depicts manganese concentration trends at monitoring wells near the west side of facility and near the former S-X Pond. Manganese concentration trends at monitoring wells in this area are generally variable with multiple spikes in concentrations at Well KM-6 in 2006, 2009, and 2011. Concentrations at Well KM-6 (currently 210 µg/L) remain above the risk-based groundwater performance standard of 180 µg/L, whereas, manganese concentrations in the other wells have declined to levels below the risk-based groundwater performance standard.

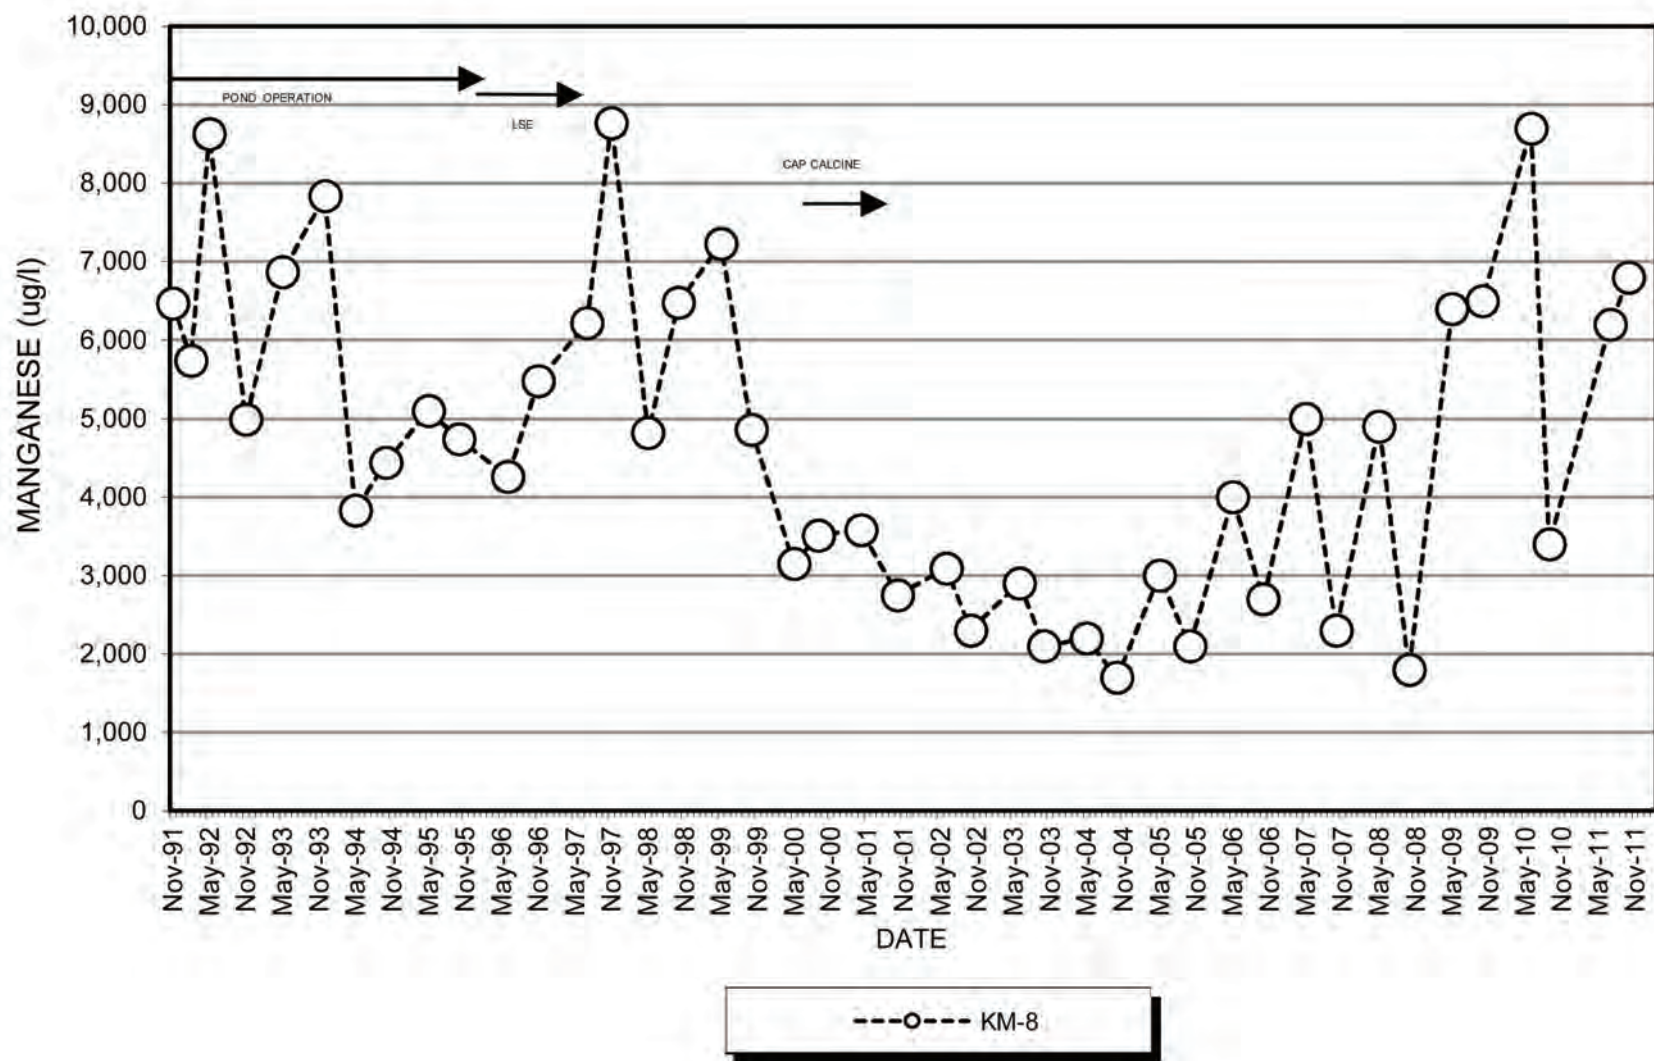
FIGURE 9
Manganese vs. Time
Well KM-8 Near Former S-X Pond
Kerr-McGee 2012 Five Year Review

As shown in Figure 9, concentrations of manganese in Well KM-8 (currently 6,800 µg/L) remain well above the risk-based groundwater performance standard and exhibit the highest concentrations at the Site. Manganese concentrations in Well KM-8 have been increasing since 2004. Concentrations of offsite wells have remained stable since 2004 and are below the risk-based groundwater performance standard of 180 µg/L (Figure 10).

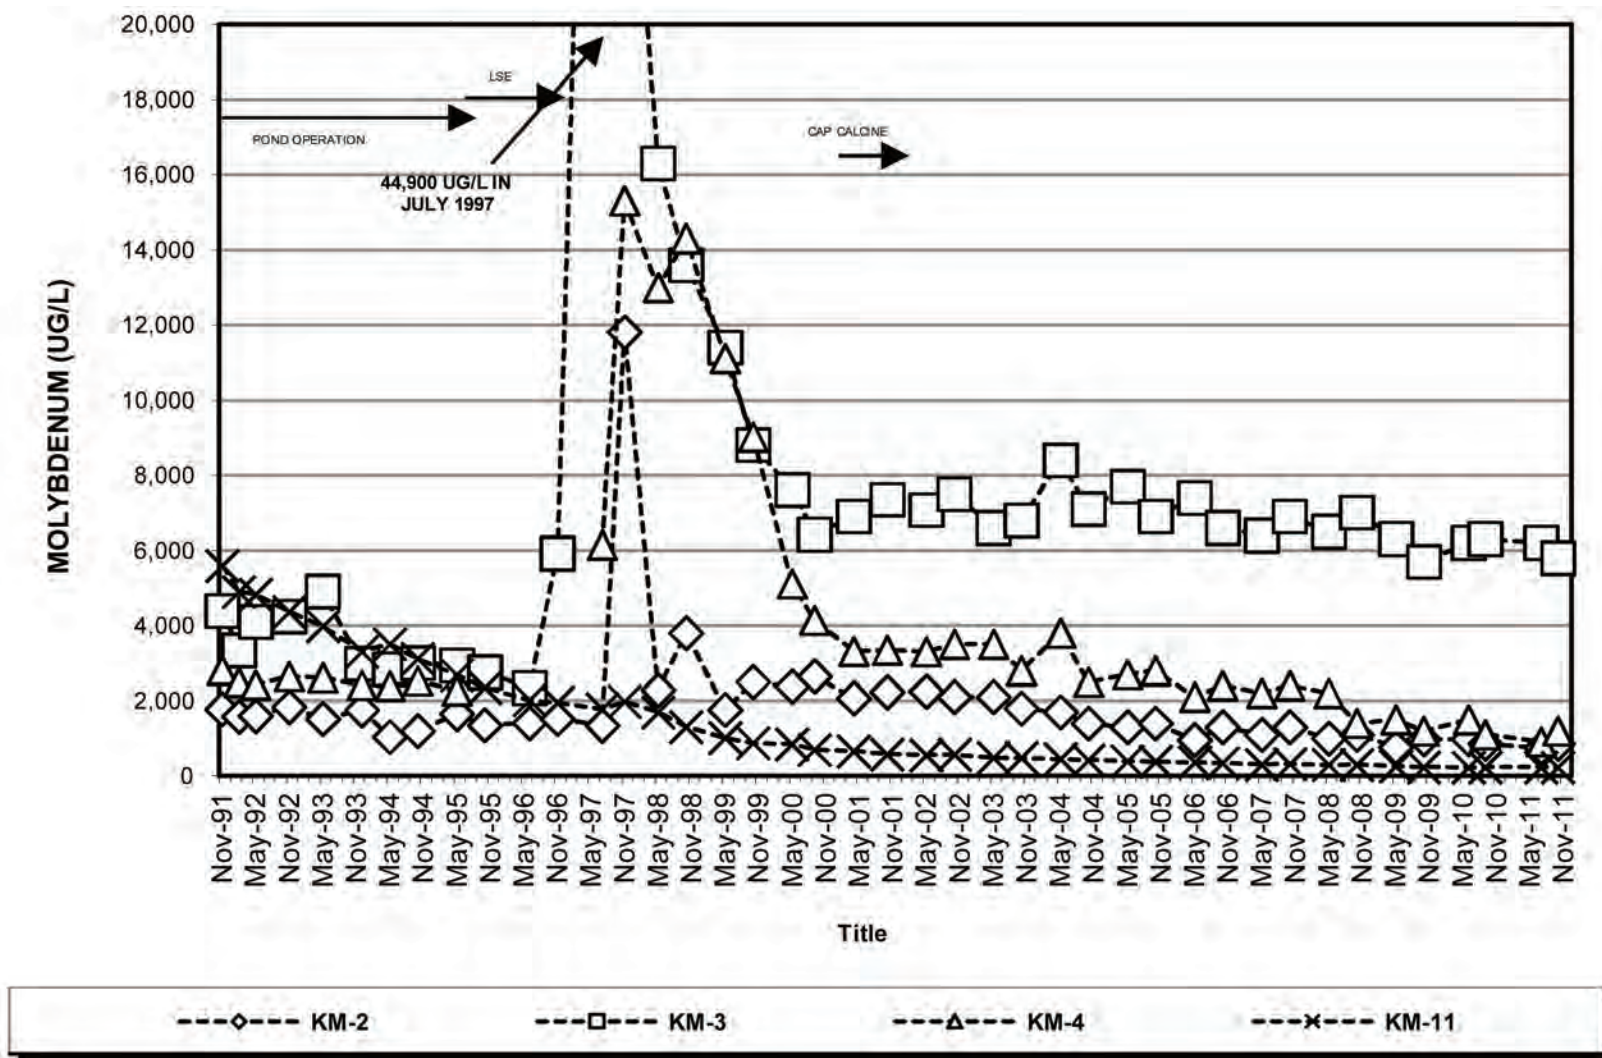
FIGURE 11
Molybdenum vs. Time
Wells Near Former Scrubber Pond
Kerr-McGee 2012 Five Year Review

All monitoring wells located near the former Scrubber Pond exhibit molybdenum concentrations well above the risk-based groundwater performance standard of 180 µg/L (highest current level 5,800 µg/L). Concentrations at these wells have shown a very slight decreasing trend since 2000 as shown in Figure 11.

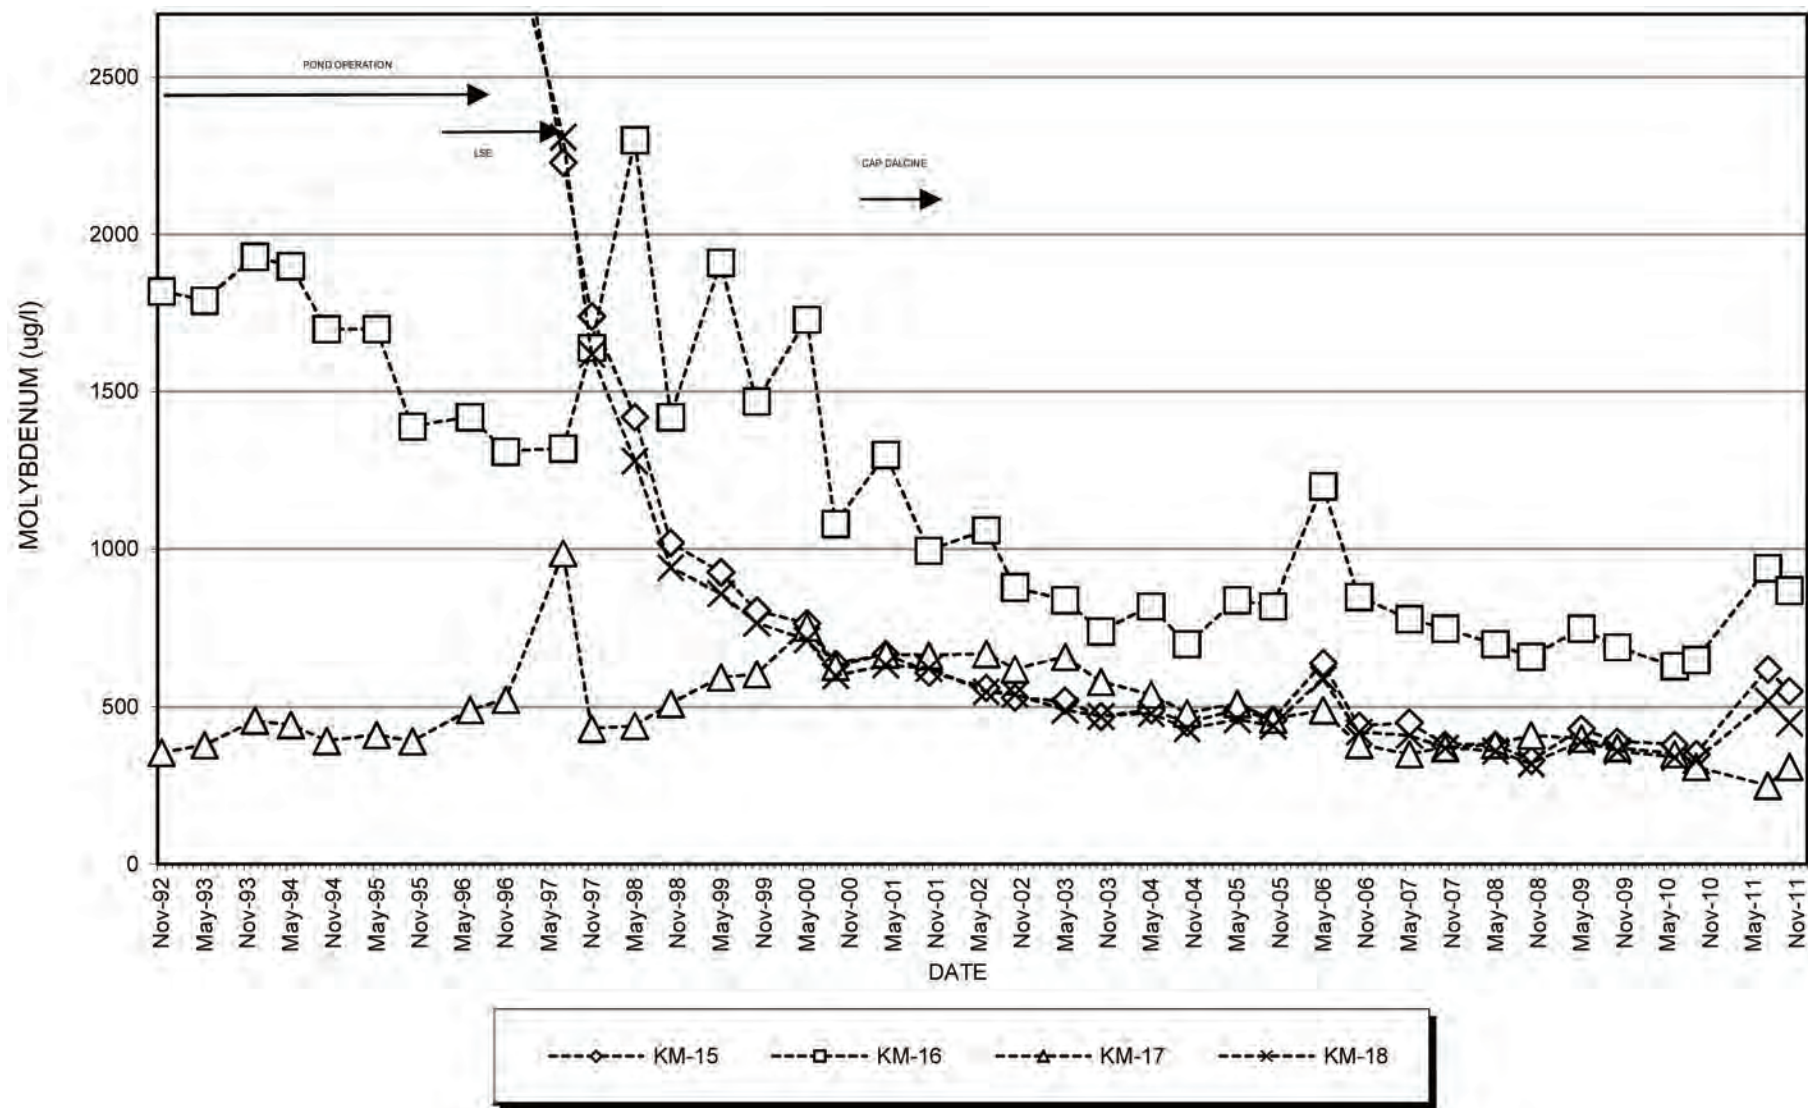
FIGURE 14
Molybdenum vs. Time
Offsite Wells
Kerr-McGee 2012 Five Year Review

Molybdenum concentrations observed in Figure 13 for Well KM-8 show a decreasing trend from 1995 to 2005. Concentrations appear to be variable from 2005 to present with no overall trend. However, concentrations at Well KM-8 (currently 42,000 µg/L) remain the highest at the Site. As shown in Figure 14, concentrations of molybdenum have shown a decreasing trend at the offsite wells since 2003, although the decreasing trend has flattened from 2003 to the present.

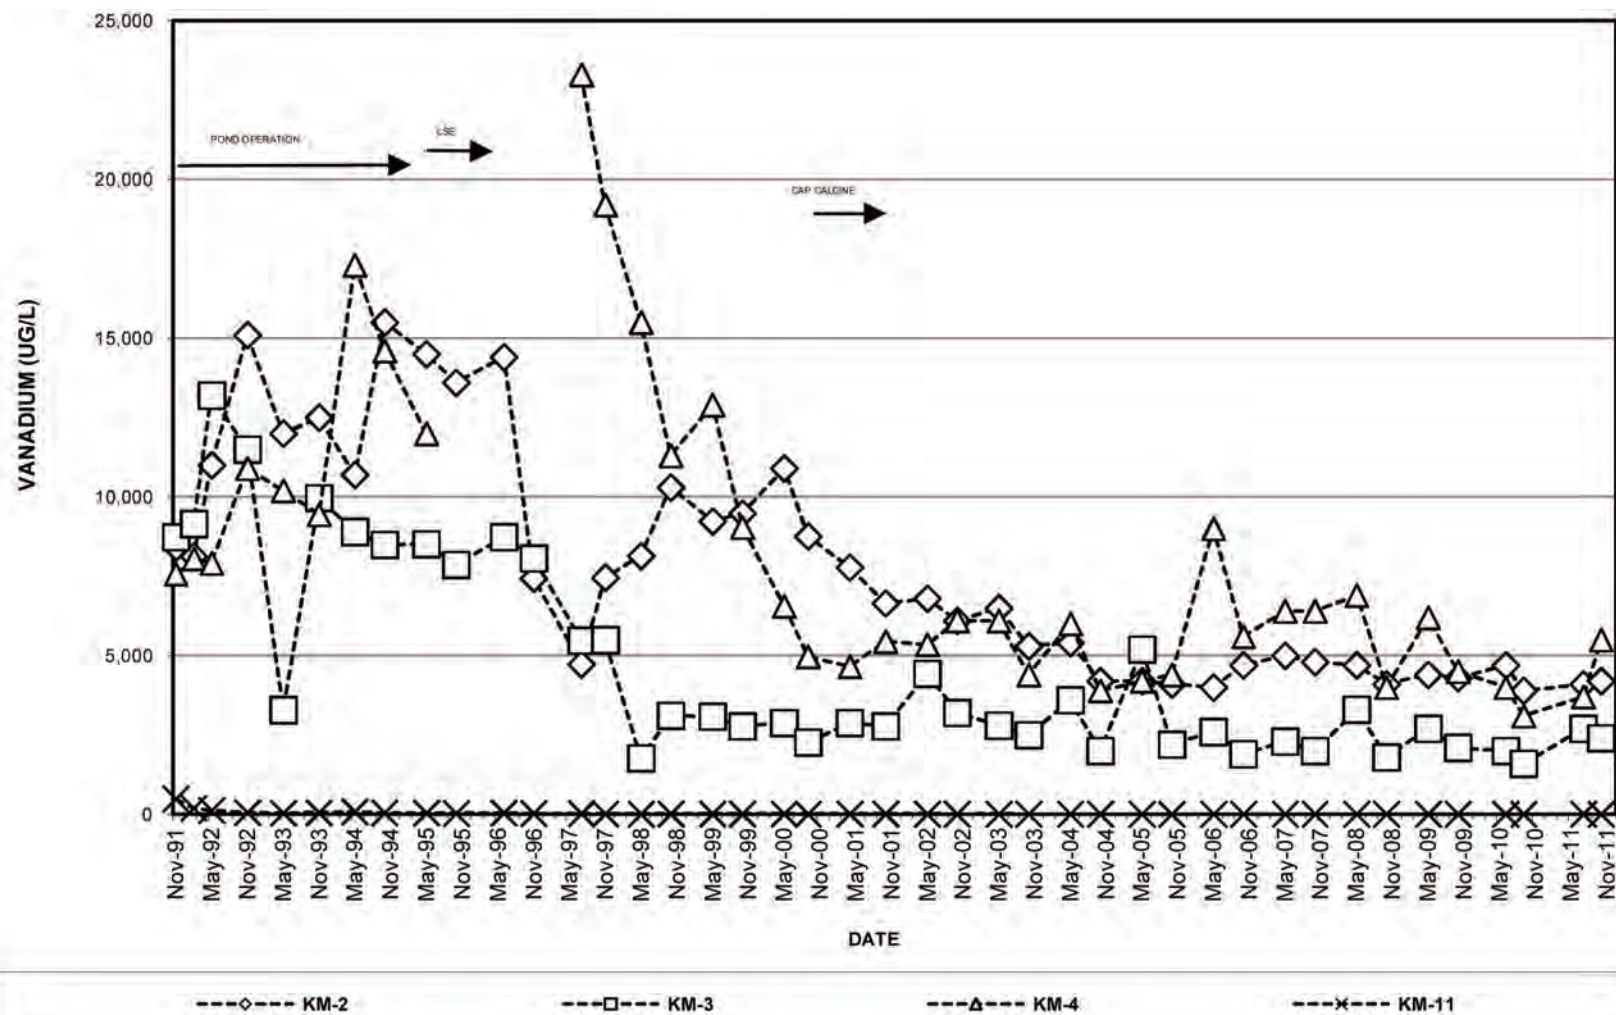
FIGURE 15
Vanadium vs. Time
Wells Near Former Scrubber Pond
Kerr-McGee 2012 Five Year Review

As shown on Figure 15, vanadium concentrations in all monitoring wells near the former Scrubber Pond with the exception of Well KM-11 remain above the risk-based groundwater performance standards of 260 µg/L (highest current level 5,500 µg/L). A significant decreasing vanadium trend in the monitoring wells occurred after eliminating the uncontrolled discharges from the S-X and scrubber ponds up until about 2000. After 2000, decreasing trends have leveled off and concentrations have remained essentially stable.

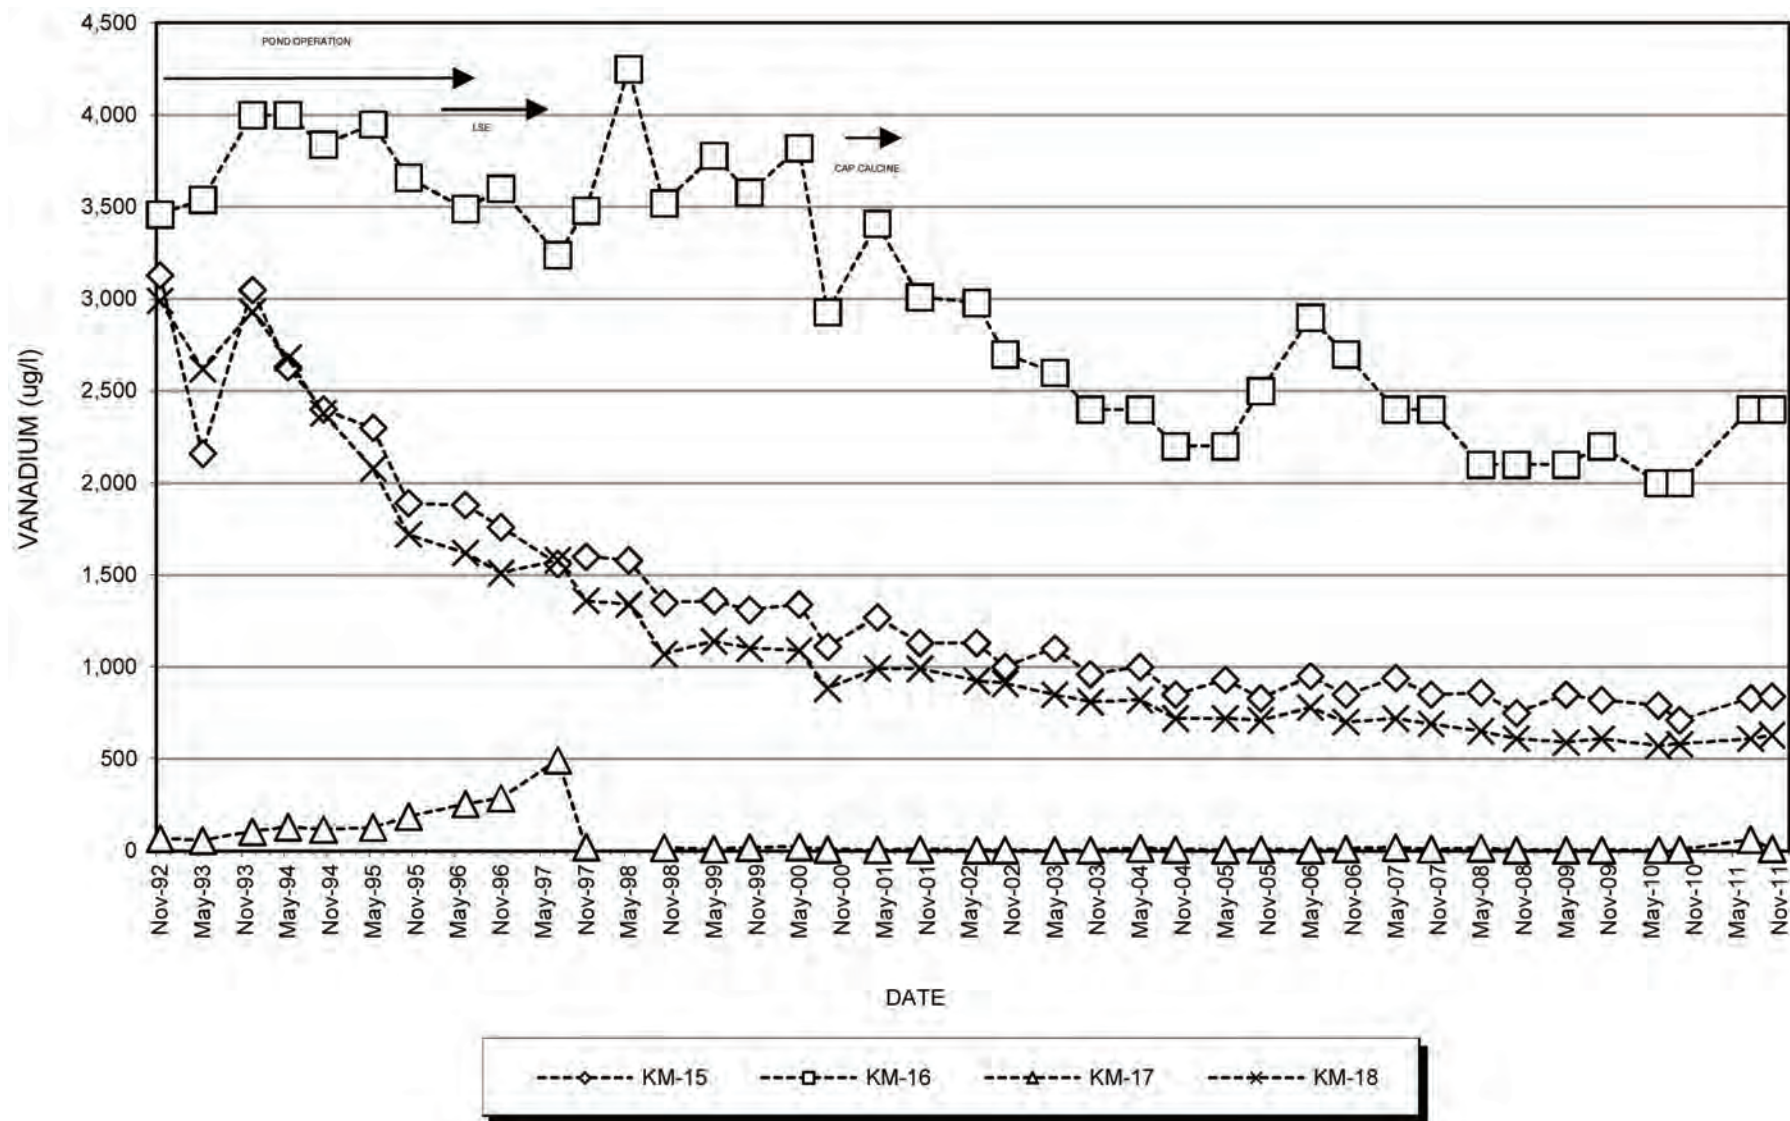
FIGURE 18
Vanadium vs. Time
Offsite Wells
Kerr-McGee 2012 Five Year Review

Vanadium concentrations at Well KM-8 have been highly variable throughout the period of study (Figure 17). A decrease in vanadium concentrations was observed from 1991 to 1995, a flattened trend from 1995 to 1999, an increasing trend from 1999 to 2004, and finally a decreasing trend from 2004 to the present. Concentrations of vanadium at Well KM-8 (currently 13,000 µg/L) remain the highest at the site and exceed the risk-based groundwater performance standard of 180 µg/L. Concentrations at the offsite wells remain above the risk-based groundwater performance standard, with the exception of Well KM-17 (Figure 18). Vanadium concentration trends at these offsite monitoring wells exhibited a decreasing trend.

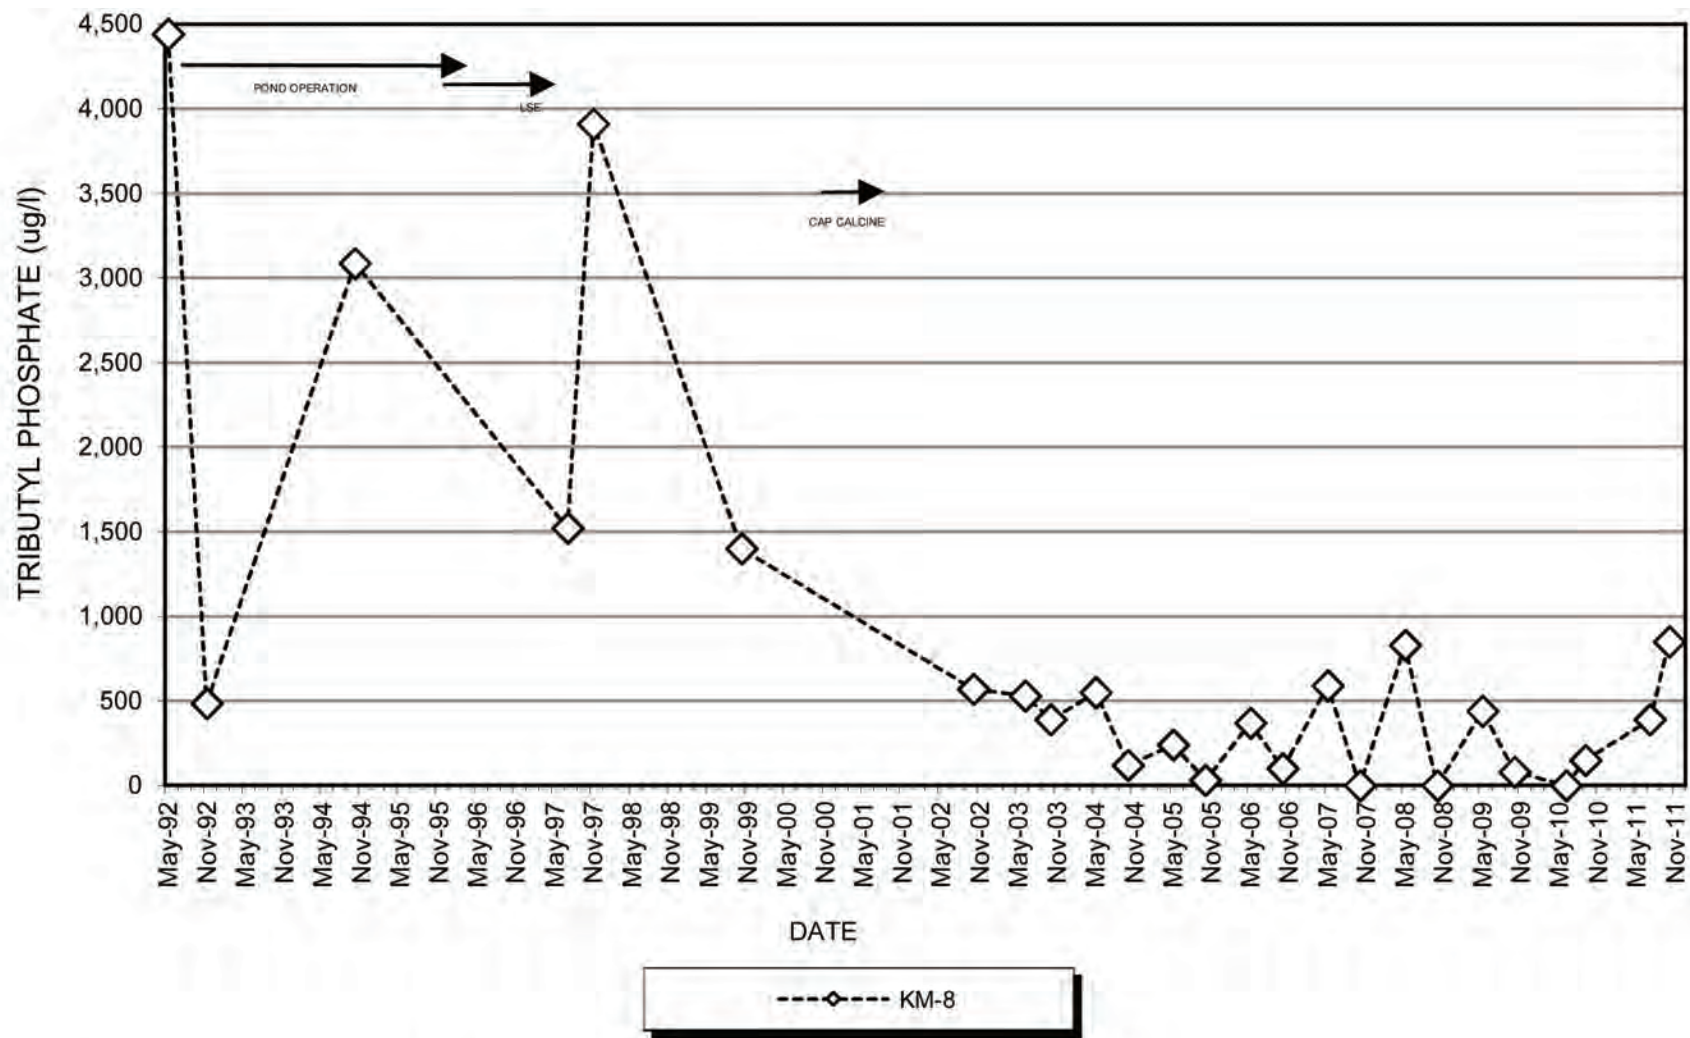
FIGURE 20
 Tributyl Phosphate vs. Time
 Well KM-8 Near Former S-X Pond
 Kerr-McGee 2012 Five Year Review

Similar to TPH, Well KM-8 is the only well that is routinely sampled for tributyl phosphate. Concentrations of tributyl phosphate in Well KM-8 decreased through 2005 (Figure 20). Concentrations from 2005 to present appear to have a slight increase with seasonal fluctuations. Concentrations at Well KM-8 (currently 850 µg/L) remain above the risk-based groundwater performance standard of 180 µg/L.

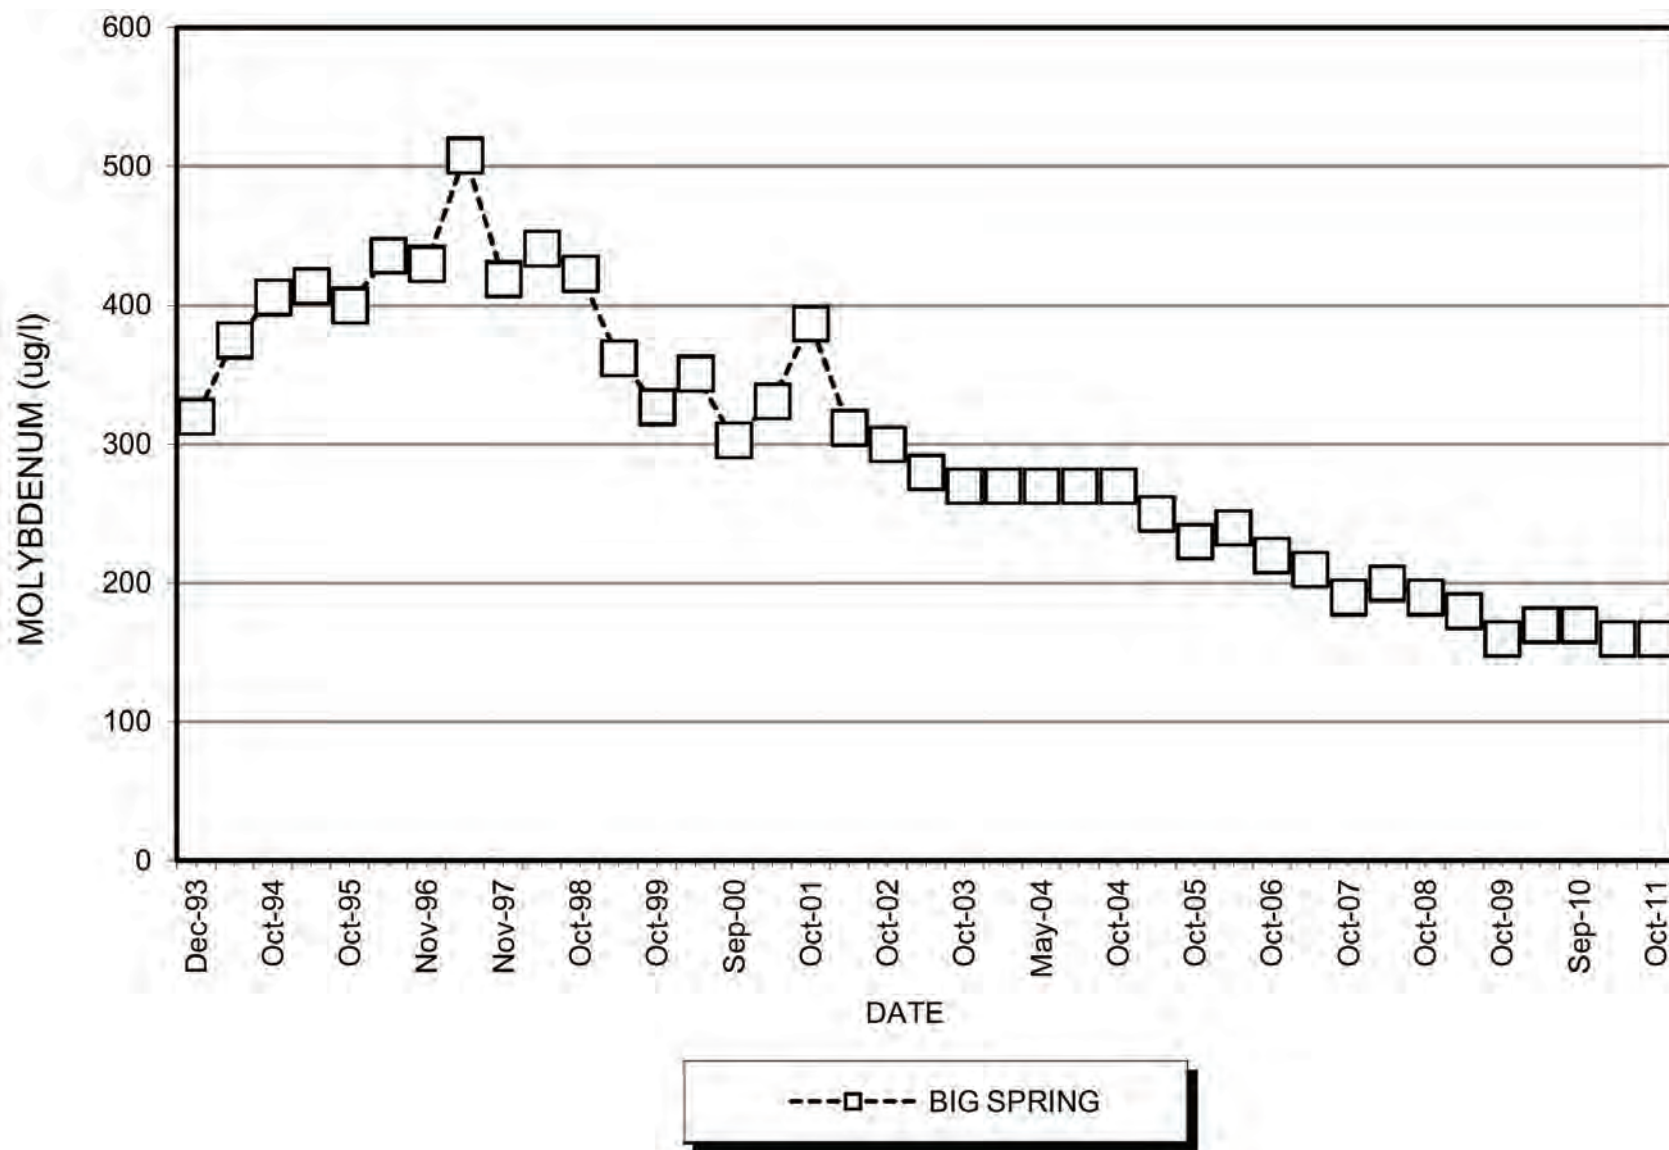
FIGURE 21
Molybdenum vs. Time
Big Spring
Kerr-McGee 2012 Five Year Review

Of the four offsite springs (Big Spring, Finch Springs, Upper Ledger, and Lower Ledger) sampled, Big Spring and Finch Spring have only shown historical exceedances of the risk-based groundwater performance standard for molybdenum. Concentrations of molybdenum in both Big Spring (located in the southern part of Soda Springs) and Finch Spring (north of Soda Springs) have shown a steady decline since 1998 (Figures 21 and 22). However, the trend has seen a flattening since about 2008. Current concentrations at both springs are below the molybdenum risk-based groundwater performance standard of 180 µg/L. All other COCs measured at offsite springs have consistently been below risk-based groundwater performance standards.

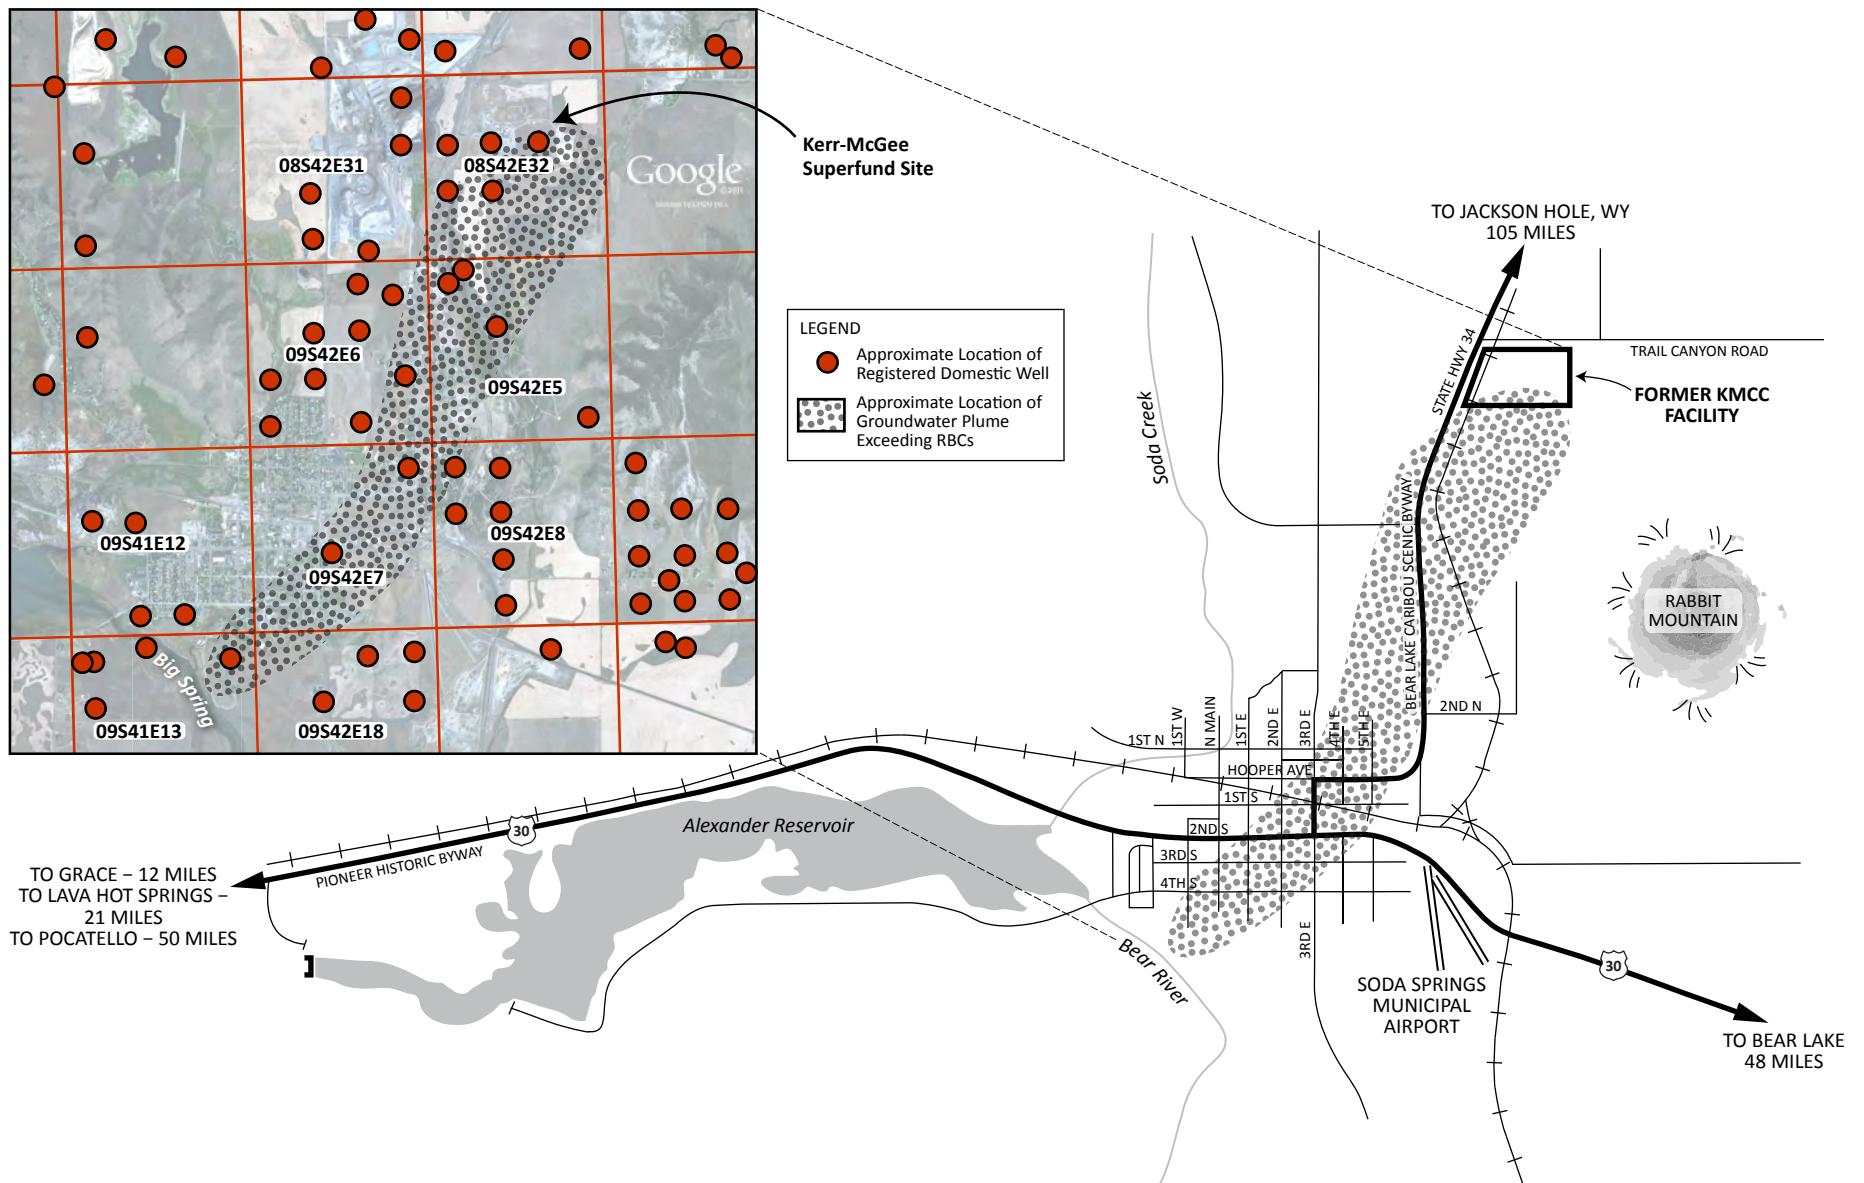
FIGURE 23
Approximate Locations of Groundwater
Plume and Registered Domestic Wells
Kerr-McGee 2012 Five Year Review

A search of the Idaho Department of Water Resources (IDWR) database provided information on registered wells in the vicinity of the Site. Detailed information on the number of wells and their intended use was limited to Township, Range, and Sections. This information was assessed with respect to the locations of these wells and a rough estimate of where downgradient plumes of site-related COCs are thought to exist. Acknowledging the high level of uncertainty of the plume locations and dimensions, available data suggests that there is a high likelihood that COC plumes may interact with or impact existing wells downgradient of the industrial facility, as depicted in Figure 23. The following types of wells are located in the specified search area boundary:
